Dry ice blasting of stainless steel

By N.W. Buijs, Van Leeuwen Stainless, The Netherlands

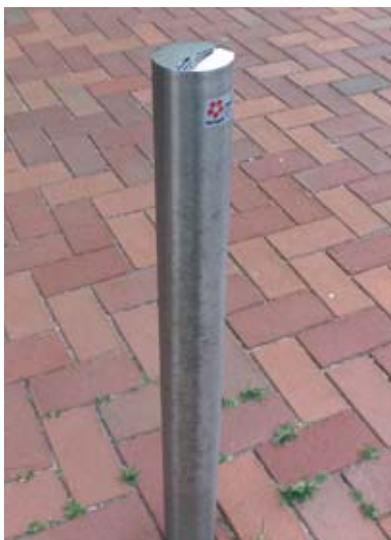
Picture 1. A stainless steel AISI 316 post, where all but the polished cap is corroded.

In external environments, stainless steel can sometimes suffer severe corrosion. Nevertheless, as a rule, its performance rates between good and excellent. The latter is especially true when using AISI 316; particularly in inland areas. Problems mainly arise along the coastline, next to railways, and sometimes also close to aggressive gas emissions from factories and vehicles. Another important contributing factor is the condition of the material's surface; the smoother the surface, the greater the material's resistance to corrosion. This is also the reason why ground stainless steel corrodes relatively quickly in maritime environments, while polished surfaces remain in good condition. Picture 1 contains an example of this – the ground tube of the post is somewhat corroded, whereas the polished cap appears to be untarnished. This post is situated on a boulevard along the coast.

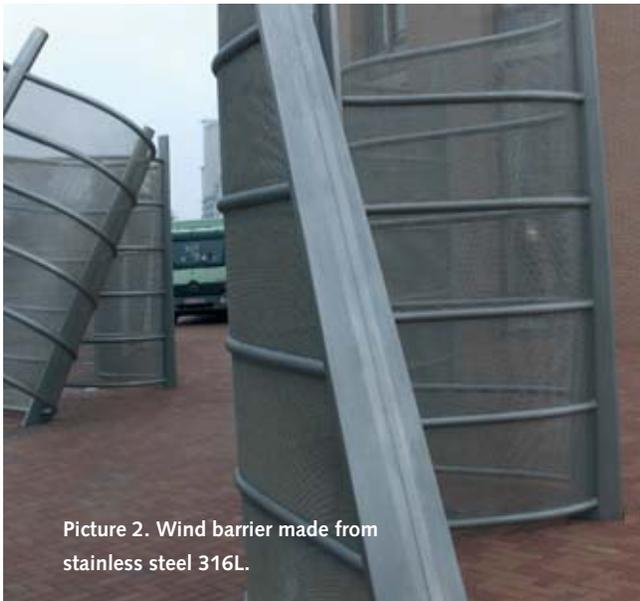
Picture 2. Wind barrier made from stainless steel 316L.

One example that appeals to the imagination is that of a 400 m² wind barrier made from stainless steel, situated on a boulevard along the coast (Picture 2). A month after being placed, this 316L stainless steel barrier was already exhibiting patches of corrosion (Pictures 3 and 4). The cause of this was indeed found to be the force of the aggressive aerosols. The rate of corrosion was also accelerated by the material's surface condition, as well as the incorrect attachment of the perforated plates to the tubes, which enabled moisture to collect (Picture 3). Although it may seem that the choice of material was incorrect, if the surface had been polished and there had been no crevices, 316L could, in principle, have been used successfully. Another noticeable thing was that welding had been carried out intermittently. Furthermore, the welds were pock-marked and irregular; a result of applying the MIG welding process, which is preferable to TIG welding when joining perforated plates.

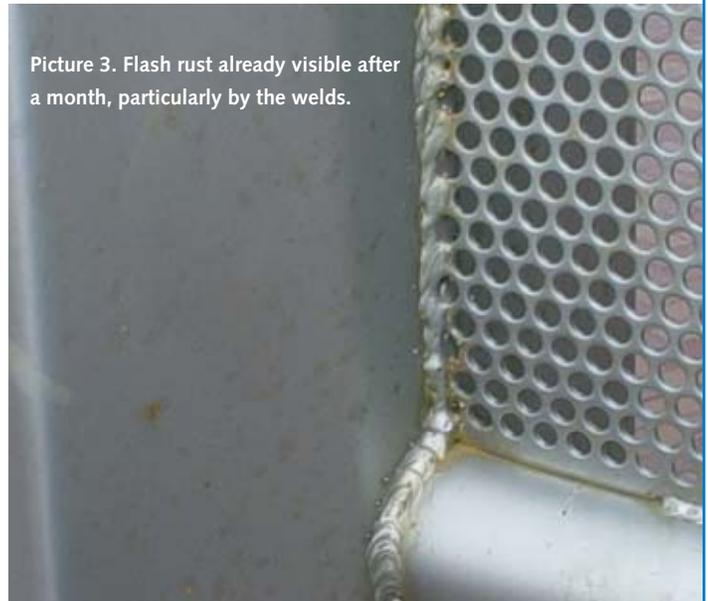
Picture 3. Flash rust already visible after a month, particularly by the welds.

rust was removed effectively within a relatively short period of time, although it had already been left a little too late. In other words, rust should be treated as soon as it is discovered. Pictures 5 and 6 show the result of dry ice blasting, which can be compared to the contents in pictures 3 and 4. It goes without saying that the difference shown is remarkable, if not unbelievable. Even the toughest rust in the

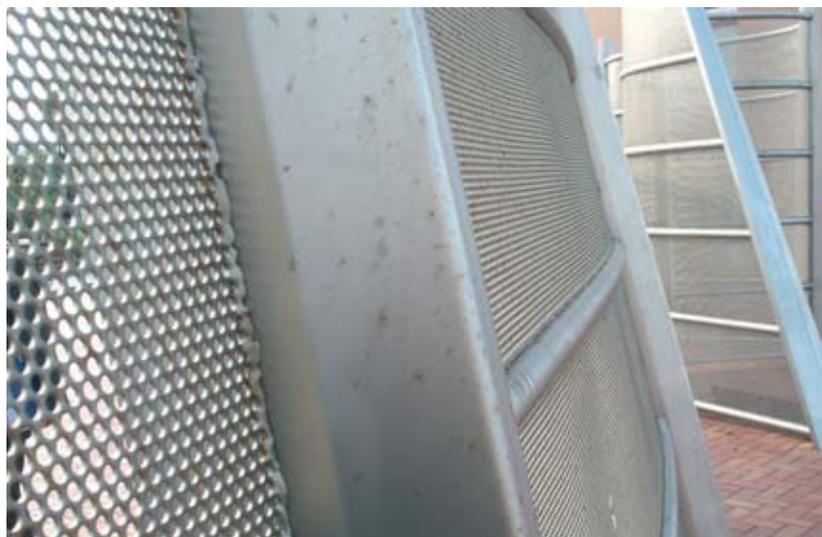
Picture 4. Rust pits showing on the design's posts.

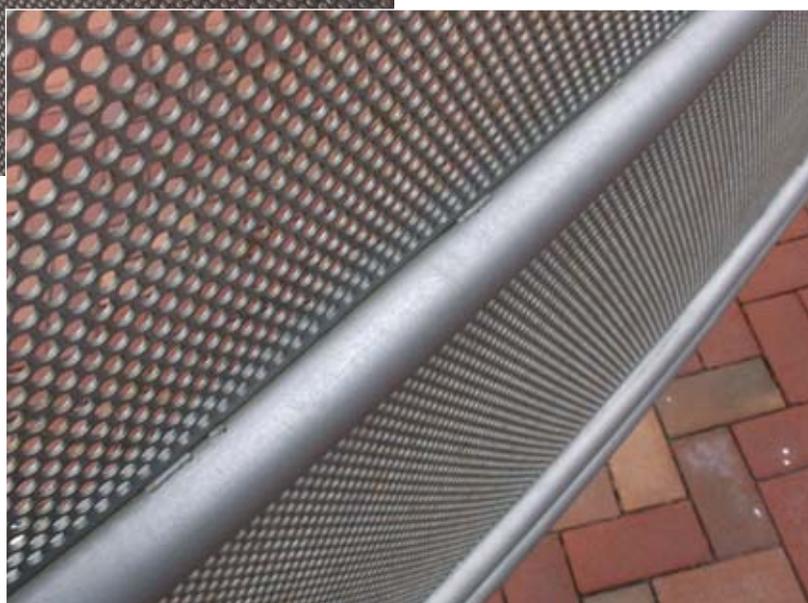
Picture 6. No more rust between the plates and tubes.

the aforementioned wind barrier after it had been cleaned with dry ice blasting, but as you can deduce from pictures 5 and 6, this treatment remains invisible. This coating can easily be applied using a dispenser and its protective qualities emerge once it is 'hardened'. The question remains, however, whether this technical wax offers sufficient protection in the crevices between the perforated plates and the tubes. If in doubt, it would be better to apply a transparent and colourless sealant to these areas.
