The danger of biological corrosion in fire systems & pipelines - Part 1

By Ko Buijs, Innomet, The Netherlands, www.innomet.nl

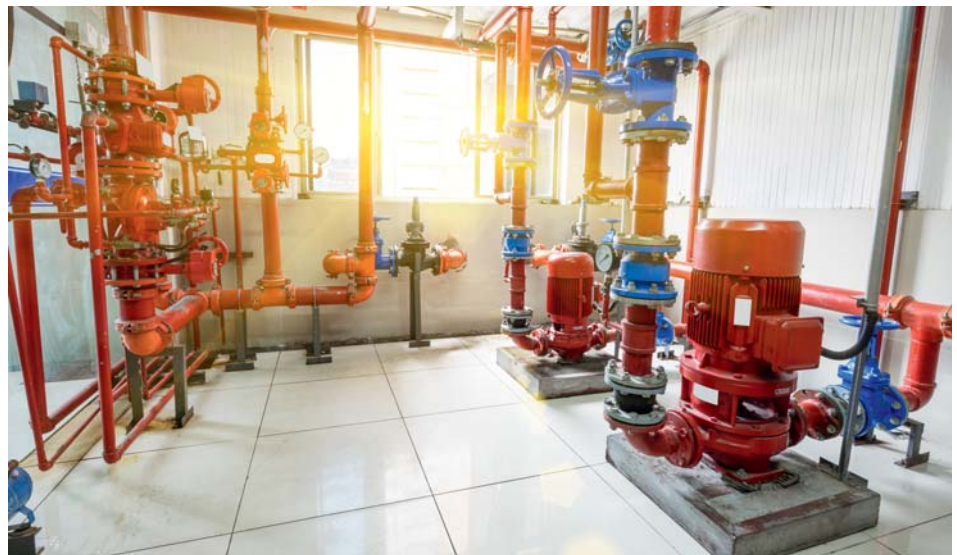
Microbiological induced corrosion is a serious threat to industrial fire protection systems and proper measures must be taken to detect and prevent it.

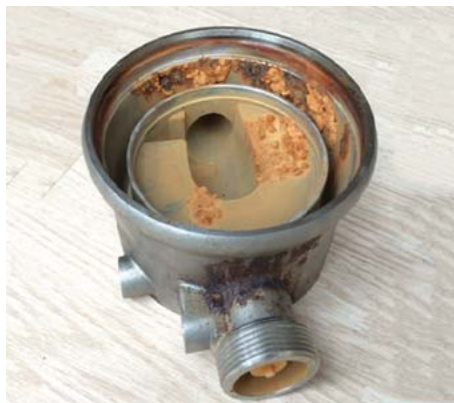
Figure 1: The foot of a pump constructed in stainless steel AISI 304 affected by MIC (photo: Innomet private company)

As metal corrodes in the anaerobic layer of the biofilm, the mentioned tubercles reagents will form. This manifests itself as rust clusters in the shape of small cauliflowers. Under these clusters, sulphuric acid occurs which attacks the material at the weakest spot while the rest is etched. That is why that next to a hole one often can see a clear affected spot.

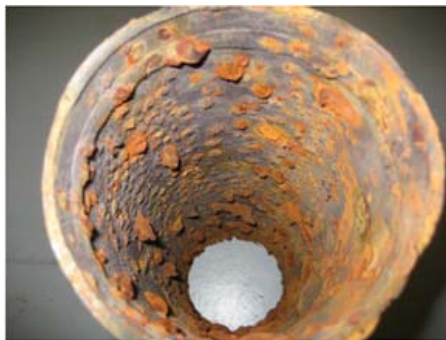
Figure 2. Steel 4" pipe affected by MIC (photo: MIC Europe private company)
