The danger of biological corrosion in fire systems & pipelines - Part 2

By Ko Buijs, Innomet, The Netherlands, www.innomet.nl

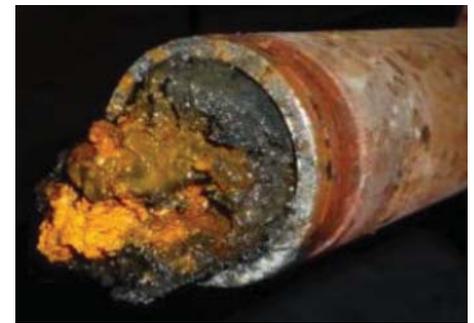
Figure 3: Steel pipe totally clogged by corrosion products (photo: MIC Europe private company)

The Biological Activity Reaction Test (BART) has been designed to determine what type of bacteria you are dealing with. This test was designed by Droycon Bio concepts in Canada, and is usually employed by labs and companies who work with corrosion control in the oil and gas sector. Determining which bacteria are involved enables a more targeted treatment. In practice, they are usually dealing with the SRBs. Sprinkler systems are filled with water which usually comes from tanks or a reservoir. The water often remains still for a long periods of time, allowing aerobic bacteria to develop optimally. The corrosion products are blackish and smelly because of the H₂S formation (rotten egg smell). The resulting reaction products clog the sprinklers (Figure 3).

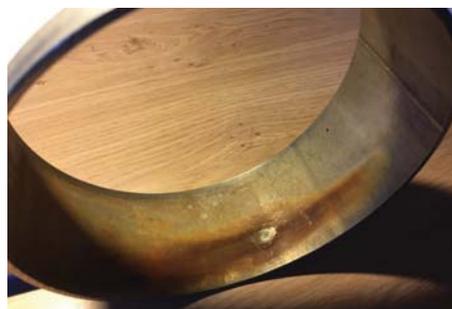
Figure 4: View of the inside of the MIC pierced 6" S10s size 316Ti pipe which had been filled with IJ river water. (photo: Innomet private company)

Fire pipes made out of stainless steel are also very susceptible to MIC, because the fire-fighting water is often in the pipes in an untreated condition for a long period of time. Because of this, the biofilm has time to develop optimally. In this way stainless steel AISI 316L pipes can be perforated in a short period of time. Figure 4 shows a specimen collected from a 6" S10s pipe with the quality 316Ti, which has holes after just six months. Around the hole, one can clearly see a bright spot which is caused by the etching of the sulphuric acid, which could be found under the (now removed) tubercles. The water in the pipes was taken from the IJ River in Amsterdam without being treated. Fire mains in road tunnels are particularly sensitive to this, particularly if the temperature is higher, as in pump rooms

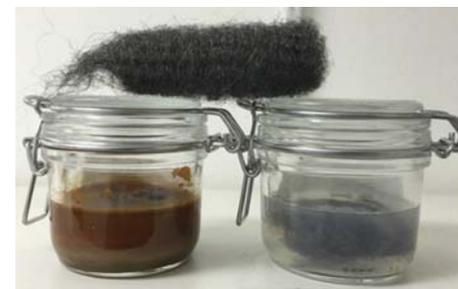
Figure 5: Test with PipeShield on steel wool: on the left is tap water, on the right tap water treated with PipeShield (photo: Innomet private company)

Figure 5 shows steel wool which was immersed in normal drinking water with and without PipeShield. After a couple of weeks, the steel wool dissolved into iron hydroxide in the untreated water, while this is not the case with water treated with PipeShield.
