FIRE SYSTEM AND PIPELINE CORROSION DANGER

Microbiologically Induced Corrosion

WORDS BY KO BUIJS, INNOMET B.V.

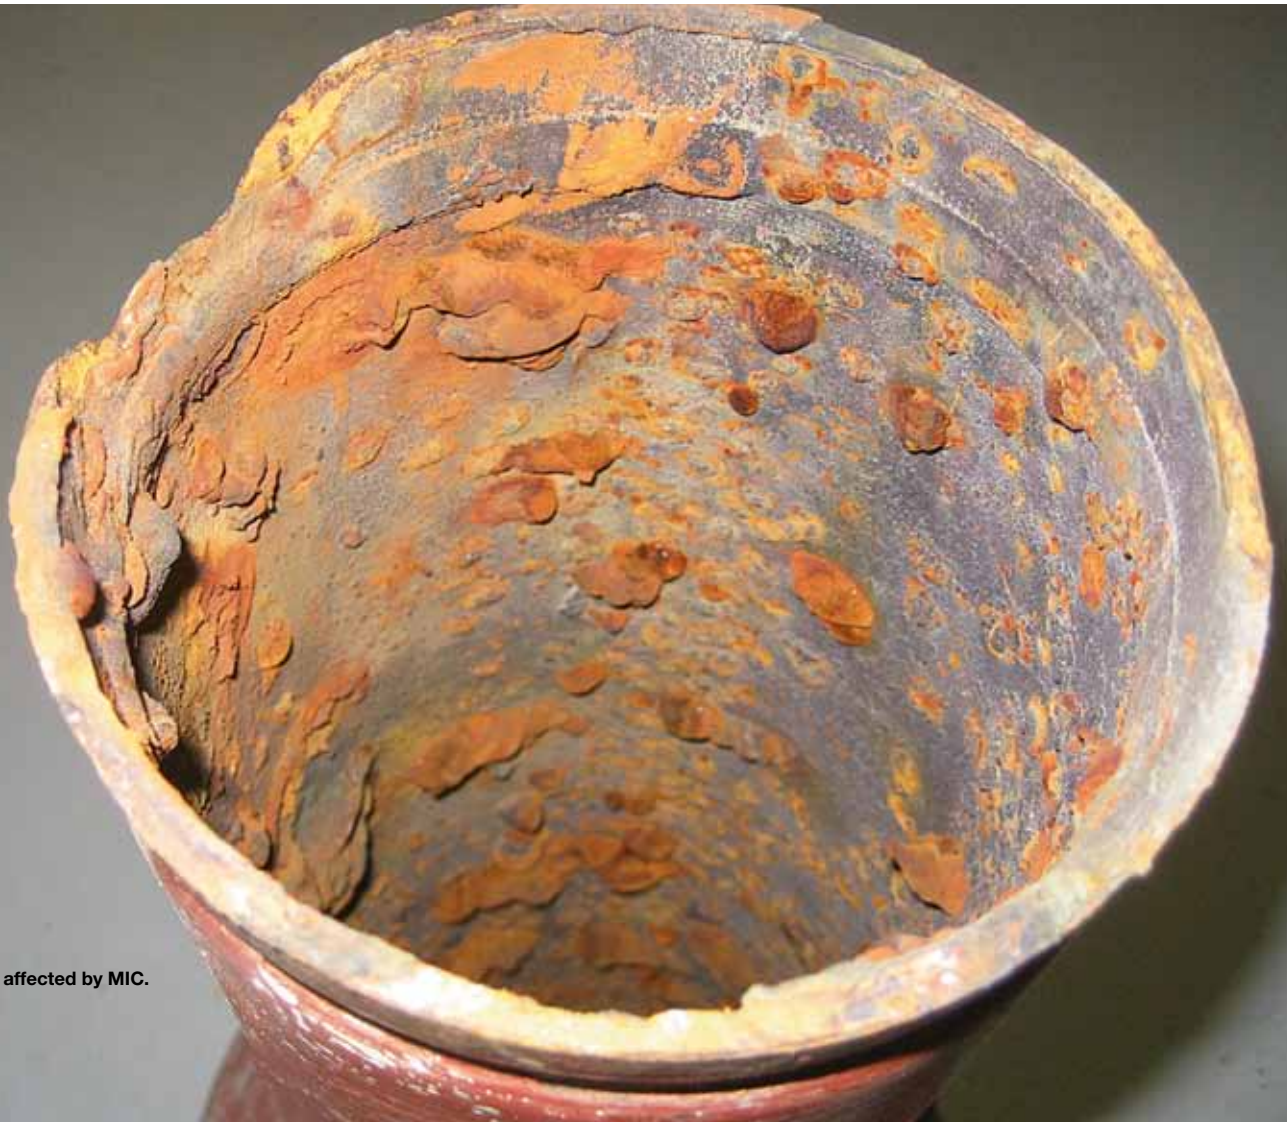
Steel pipe affected by MIC.

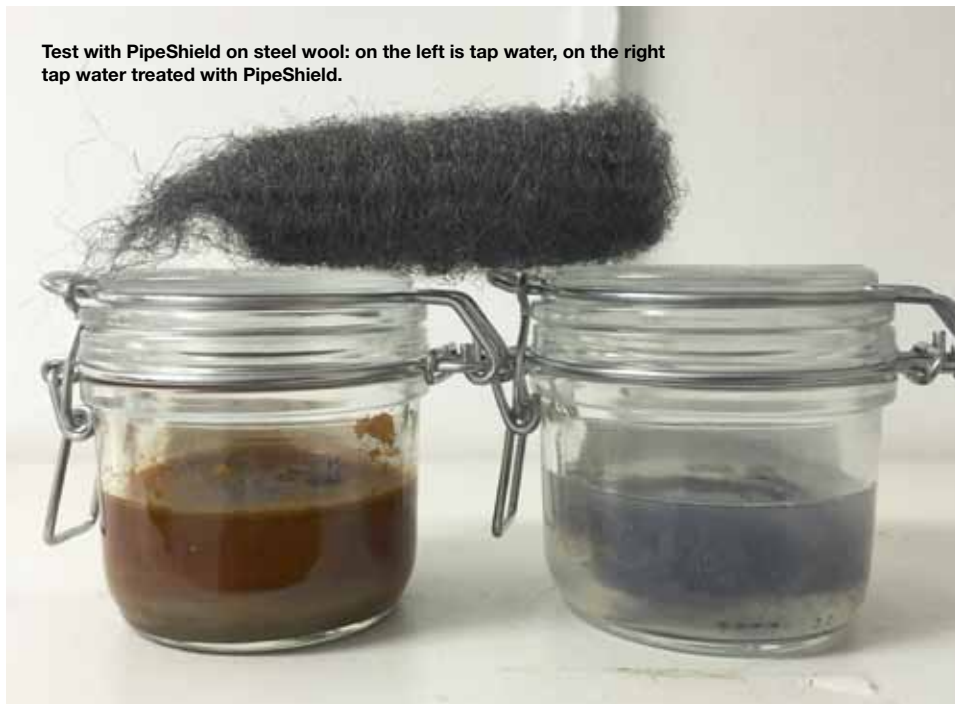
Test with PipeShield on steel wool: on the left is tap water, on the right tap water treated with PipeShield.

One product that can help protect metals from MIC is PipeShield from MIC-Europe. PipeShield is a REACH-registered product, which is added to water to create a protective layer on the surface. This layer is only atoms thick, but still offers a high resistance against the microbiologically induced corrosion. PipeShield enables micelles (lipid molecules that arrange themselves in a spherical form in aqueous solutions) to accrete as a surfactant substance on the metal wall, protecting it from MIC. Moreover, bacteria and micro-organisms are encapsulated by this surfactant, whereby their corrosive development is limited. During a test, steel wool was immersed in normal drinking water with and without PipeShield. After a couple of weeks, the steel wool dissolved into iron hydroxide in the untreated water, while this did not occur in the water treated with PipeShield. PipeShield is pH neutral and dissolves fully in water.

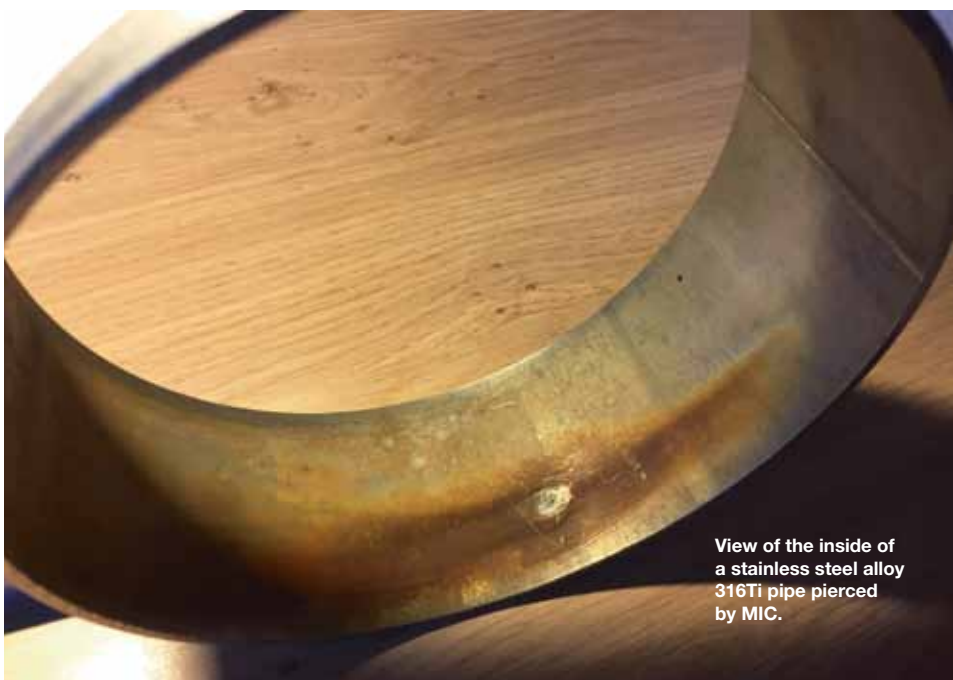
View of the inside of a stainless steel alloy 316Ti pipe pierced by MIC.
